Inspection Report
Minerals Regulatory Program

Mine Name: Lime Ridge
Operator Name: Holliday Construction

Permit number: M/037/081
Inspection Date: February 22, 2006
Time: 5:40-6:00 PM

M/037/081, Lime Ridge Mine, Holliday Construction

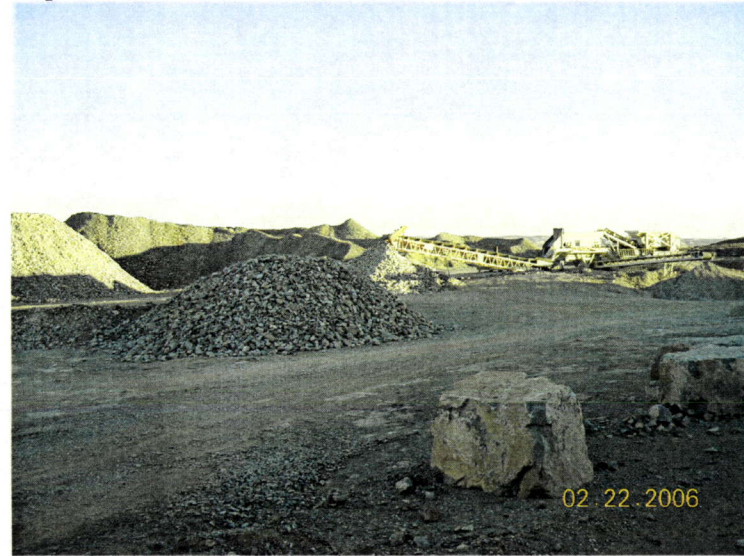
Photo 3. A view of some of the stockpiles and screening equipment.

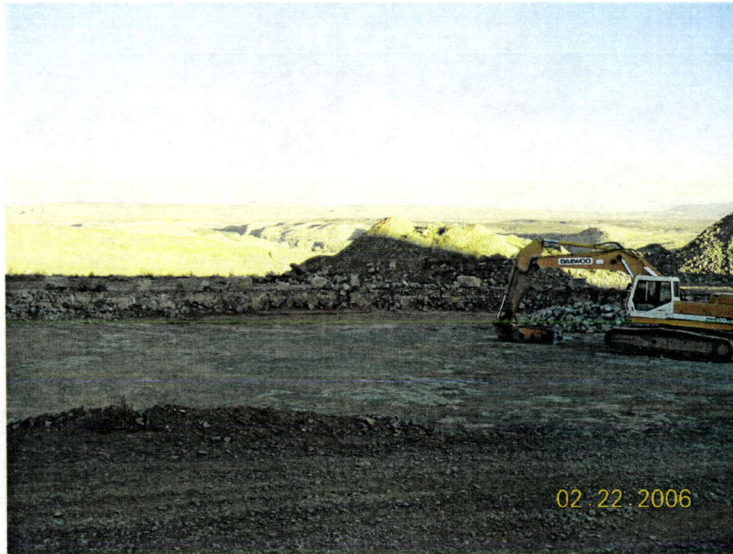
It appears the operator has mainly been crushing and screening existing stockpiles, but there may have also been some mining since the last inspection in 2004. Equipment at the site included a trackhoe, a conveyor, screen, and, I believe, a crusher. The disturbed area has not been expanded since I first visited this site in 2001.

Photo 2. The operator may have recently done some mining in this area which is near the entrance to the site.
